# BUCKS COUNTY STORMWATER MANAGEMENT PLAN WATERSHED PLAN ADVISORY COMMITTEE (WPAC) WORKSHOP NO. 3 – PHASE 2 KICK-OFF

APRIL 10, 2025

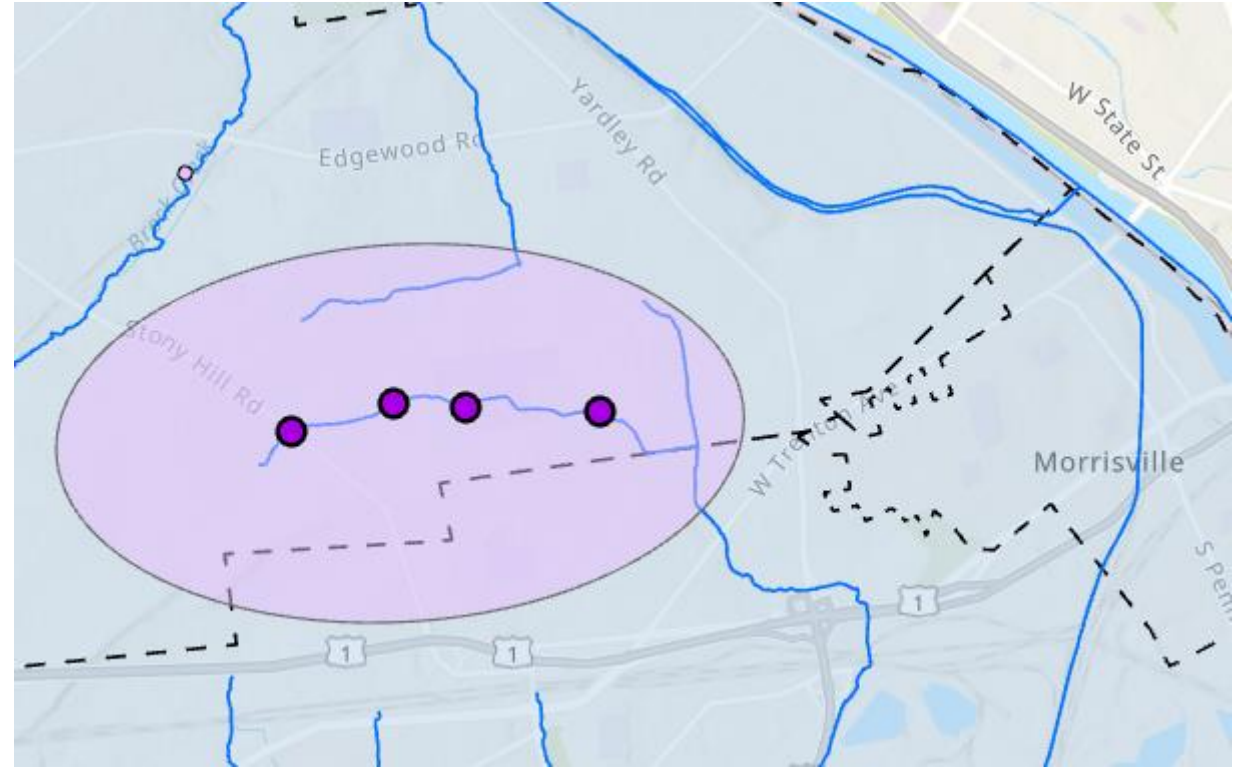
# ROCK RUN CREEK

- Flooding occurs at undersized culverts
- Problem sites were identified in the Delaware River South Act 167 Plan
